## Pipe assembly blows off, strikes operator

### Purpose of this report

Number: 2005144250175

Core activity: Well stimulation

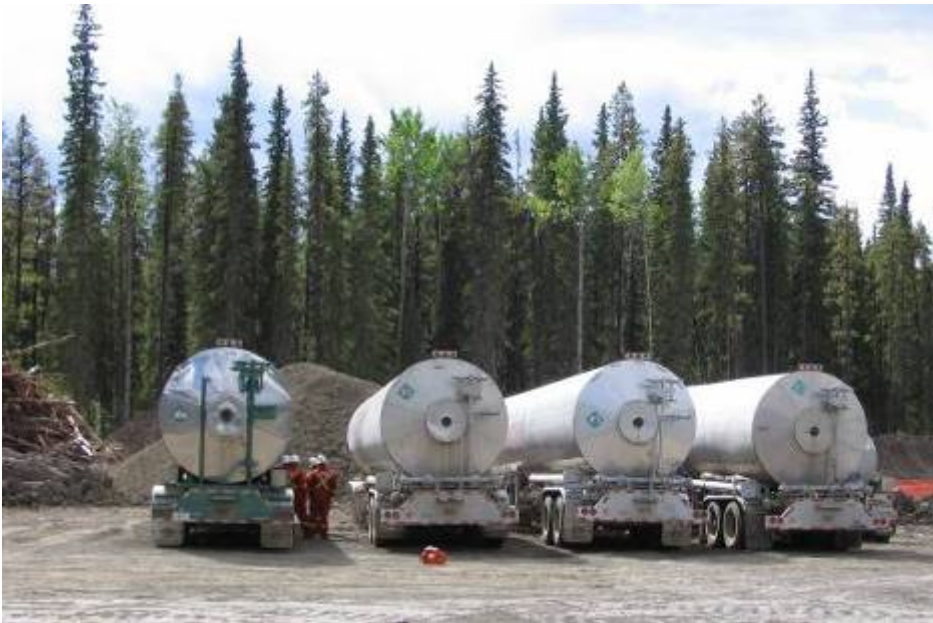
Photo 1: Rear view of the four mobile tanker units (called queens). The incident occurred between two queens, near the position of the workers in the photograph.

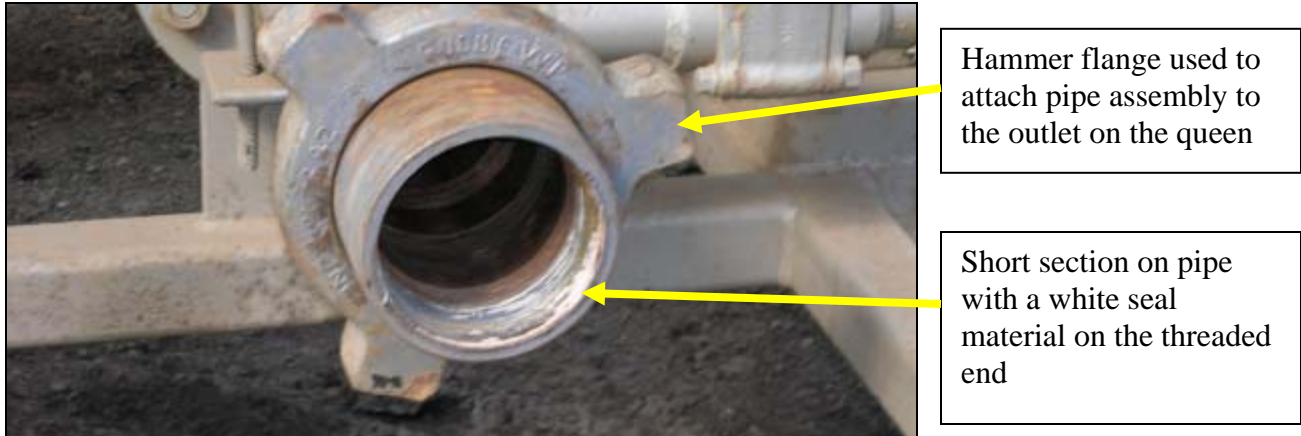
Photo 2: The first connection of the pipe assembly. A short (8-inch) section of pipe was attached to the outlet on the queen with a hammer flange.

assembly involved in the incident were SKD 80, but the straight pipe used to connect the pipe assembly to the outlet was SKD 40 and therefore had a thinner wall.

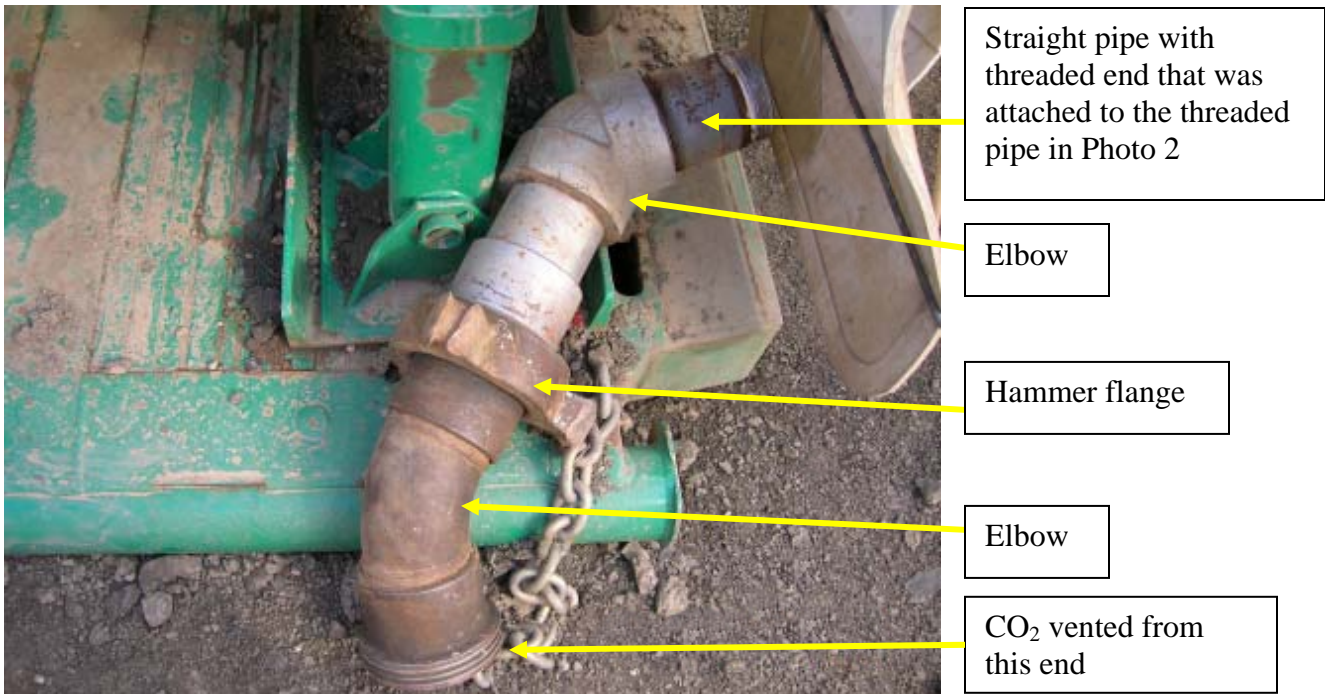
Photo 3: The vent pipe was assembled on-site and used to direct the venting CO<sub>2</sub> gas away from the adjacent queen.

The vent pipe constructed at the work site was assembled from elbows and connecting flanges of SKD 80 pipe and one straight piece of SKD 40 pipe approximately 8 inches long. The entire pipe assembly had a nominal inside dimension of 4 inches.

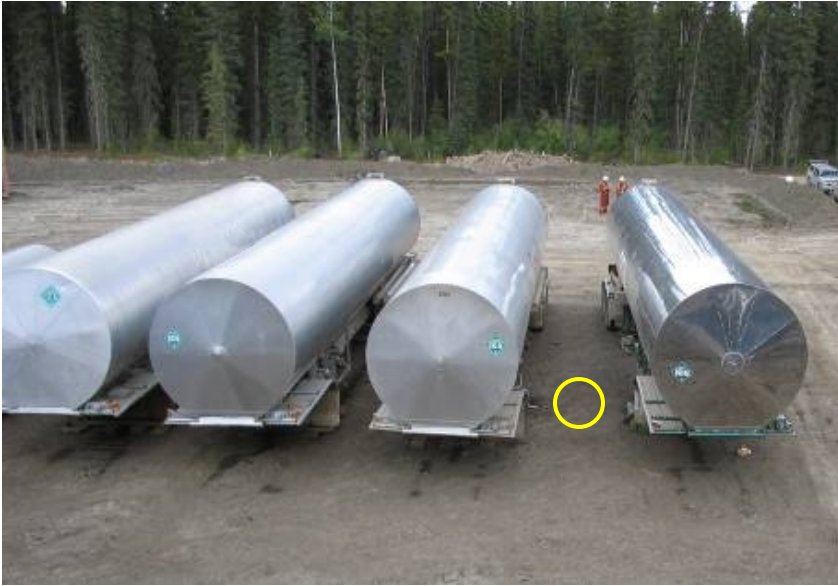
Photo 4: This view shows the front of the queens. The circle shows where the CO<sub>2</sub> operator was standing at the time of the incident.

In addition, the procedure for venting queens does not indicate where the CO<sub>2</sub> operator should stand when opening the valve. The CO<sub>2</sub> operator was close to the vent pipe assembly as it began to spin, because the discharge lever that the CO<sub>2</sub> operator had to turn was behind and above the outlet (see Photo 6). However, the operator could stand on the opposite side of the queen and reach in to turn the discharge lever.

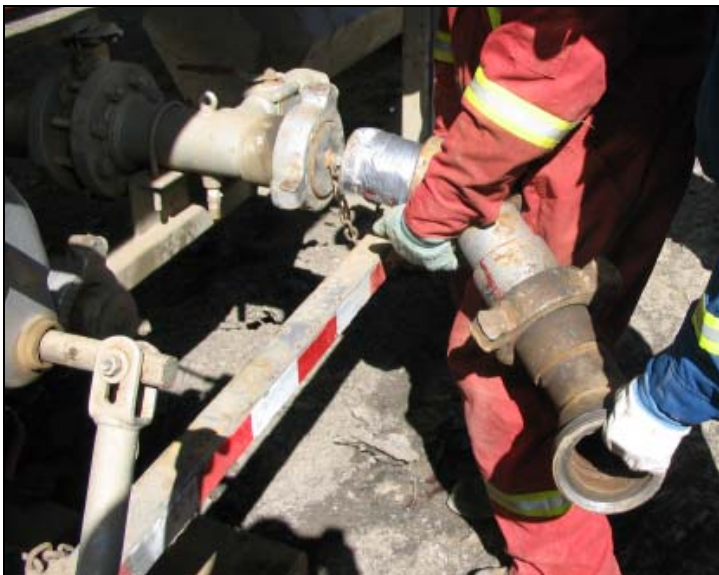
Photo 5: After the incident, workers indicate the position of the vent pipe assembly when the CO<sub>2</sub> operator attached it to the queen.

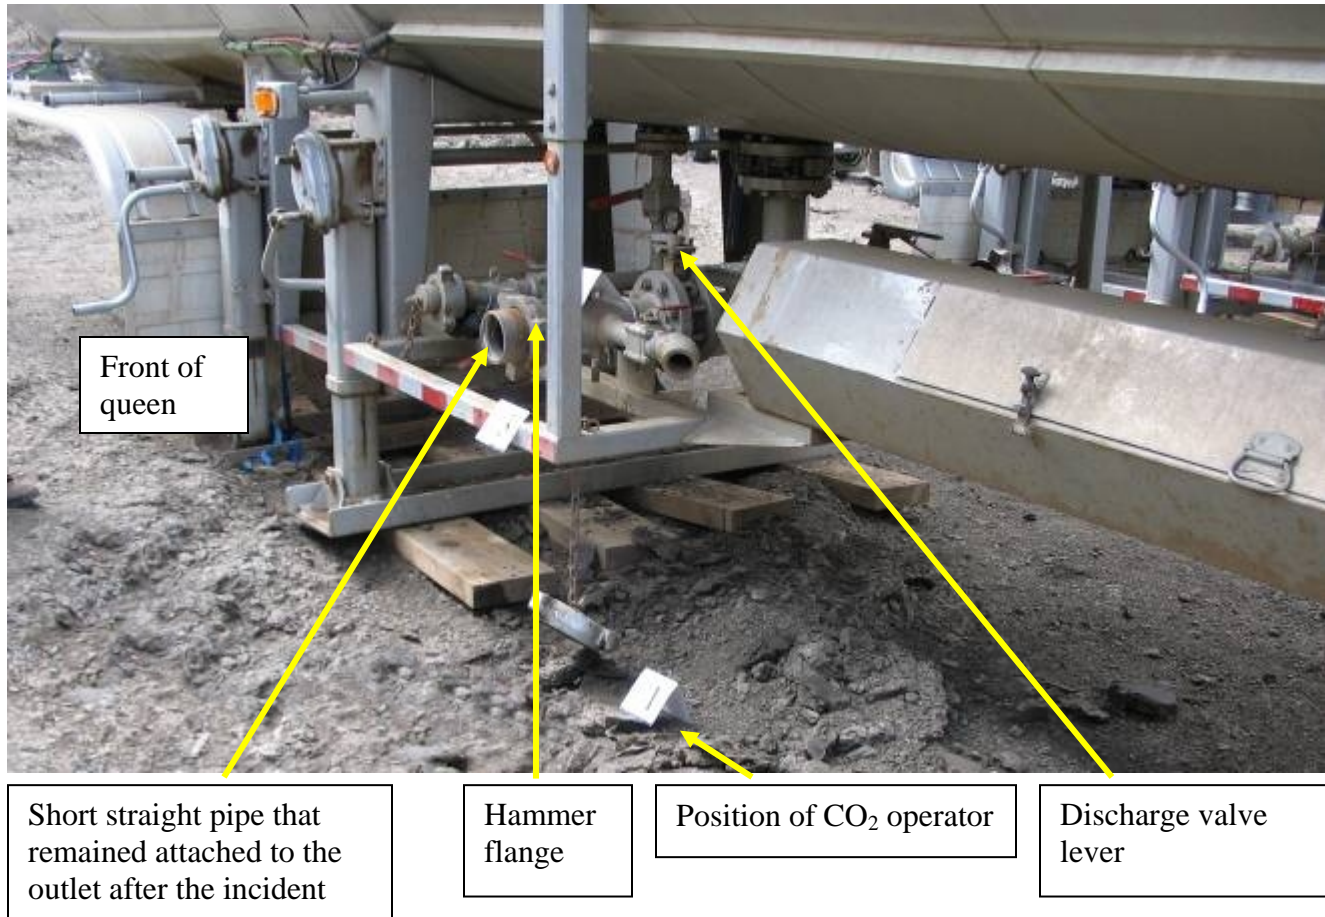
Photo 6: The pipe assembly shown in Photo 5 was positioned to vent the gas towards the front of the queen. It turned counterclockwise as it unthreaded. One piece of straight pipe remained attached to the outlet; the rest of the pipe assembly spun off.

WorkSafeBC engineering calculated that the forces of the venting gas acting on the 4-inch pipe were significant and led to the unthreading of the pipe, causing it to spin and strike the CO<sub>2</sub> operator (see Photo 6). A WorkSafeBC engineer examined the pipe assembly and reported on the possible reason that the pipe disconnected while the gas was venting. The engineering report states that there could have been a torque of 2,200 foot-pounds tending to unthread the pipe. The engineering report states:

It is likely that the torque required to make or break this threaded fitting was in the order of 200 foot-pounds, which is equivalent to a 100-pound pull on the end of a 2-foot long wrench. Therefore, the nozzle created by the end of the pipe where the carbon dioxide exited only had to be 10 percent efficient in converting the tank pressure into thrust in order to rotate off a tight pipe fitting. This could reasonably have been achieved.

The engineering report concludes that the most likely cause of the incident is that compressed gas escaping from the end of a 45-degree pipe elbow created a thrust. The relative orientation of the thrust and distance of the 45-degree elbow from the axis of rotation of a threaded pipe joint caused the pipe to unthread. The threaded connection was not tight enough to resist the torque created by the escaping jet of gas. The engineering report also concluded that the white substance on the pipe threads may have acted as a lubricant, allowing the pipe to unthread at a lower torque.

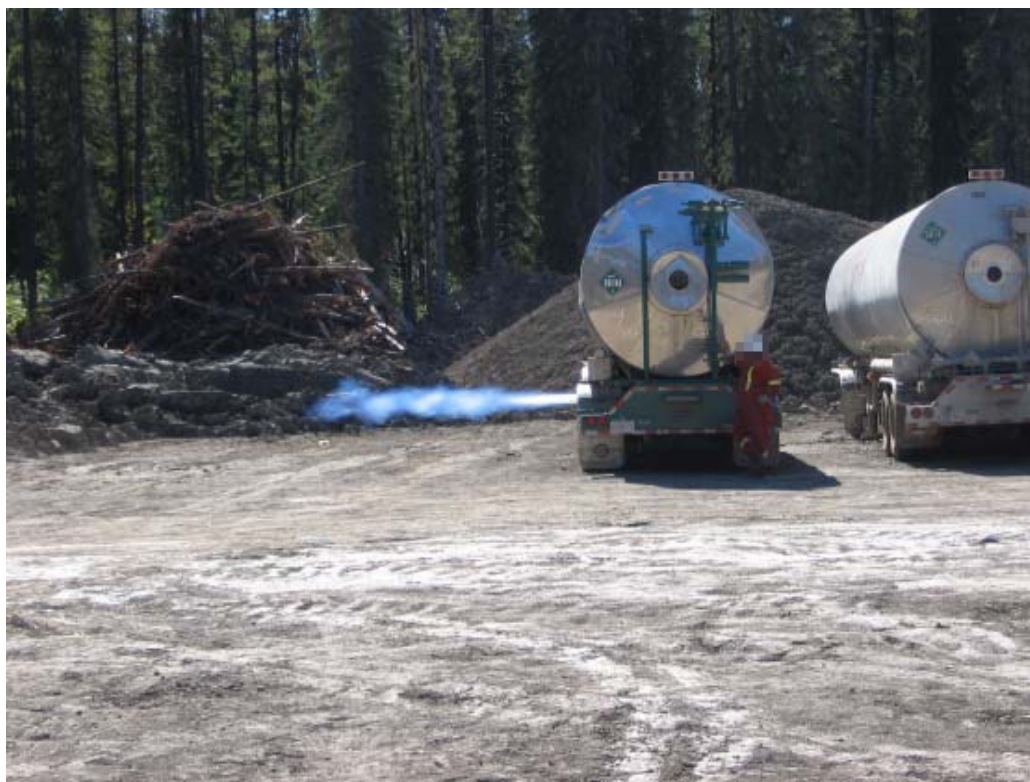
Photo 7: CO<sub>2</sub> is vented at a pressure of approximately 300 psi through a 4-inch-diameter pipe.
